# District of Mackenzie

## *2020 Water System Annual Report*

June 2021, R1

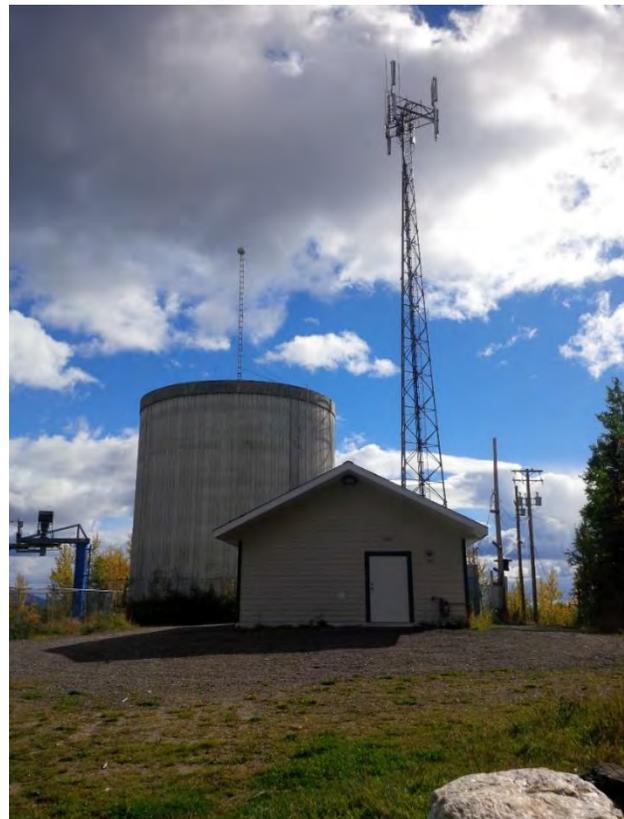
**Figure 2.1: Town Reservoir**

For in-town residents, water is sourced from three groundwater wells, two located in Pumphouse 1 at First Beach (Wells #1 and #5) and one in Pumphouse 2 at Second Beach on Morfee Lake (Well #3). Well #1 has an emergency diesel backup motor. The wells draw water from an aquifer composed predominantly of sands and gravels. The well depths, according to the logs at the time of construction, range from 12-21 m. Pumphouses 1 & 2 pump water to a 2,250 cubic meter storage reservoir, located next to Little Mack Ski Hill. The reservoir is a large, above ground concrete structure.

In 2019, the District inspected the Town reservoir to confirm manganese deposits within the reservoir were not being carried into the distribution system. There were no signs during this inspection that manganese deposits were a concern.

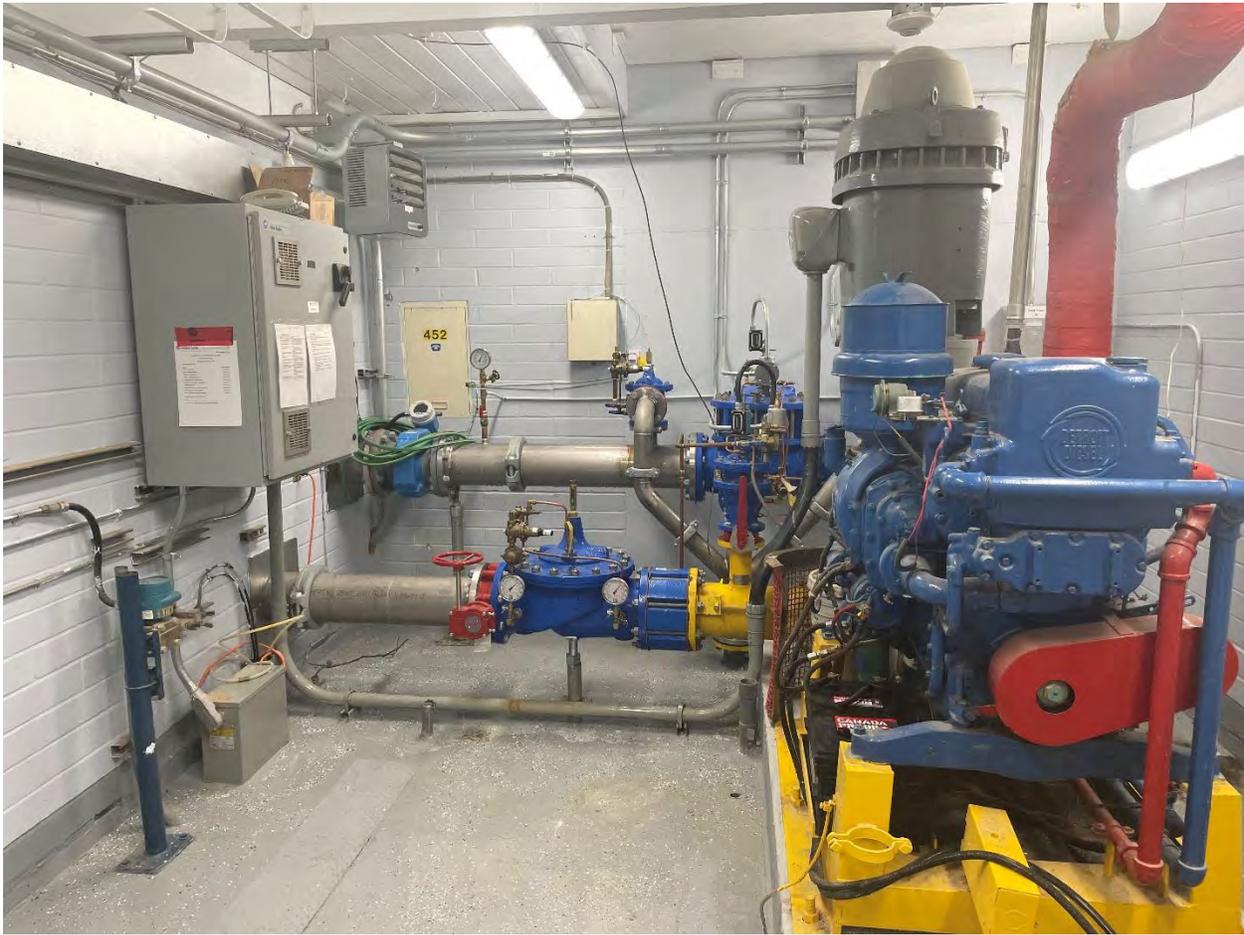
**Figure 2.2: Town Pumphouse 1**

The project included updates to the existing Pumphouse 1, including an improved power supply and modern controls. The project was completed on budget in July 2018. Figure 2.2 shows the updated Pumphouse.

In 2017, the District was successful in obtaining grant funding to improve water security by increasing the number of water sources for the Town water system. Drilling of Well #5 began in September 2017 approximately 25 ft South of Pumphouse 1.

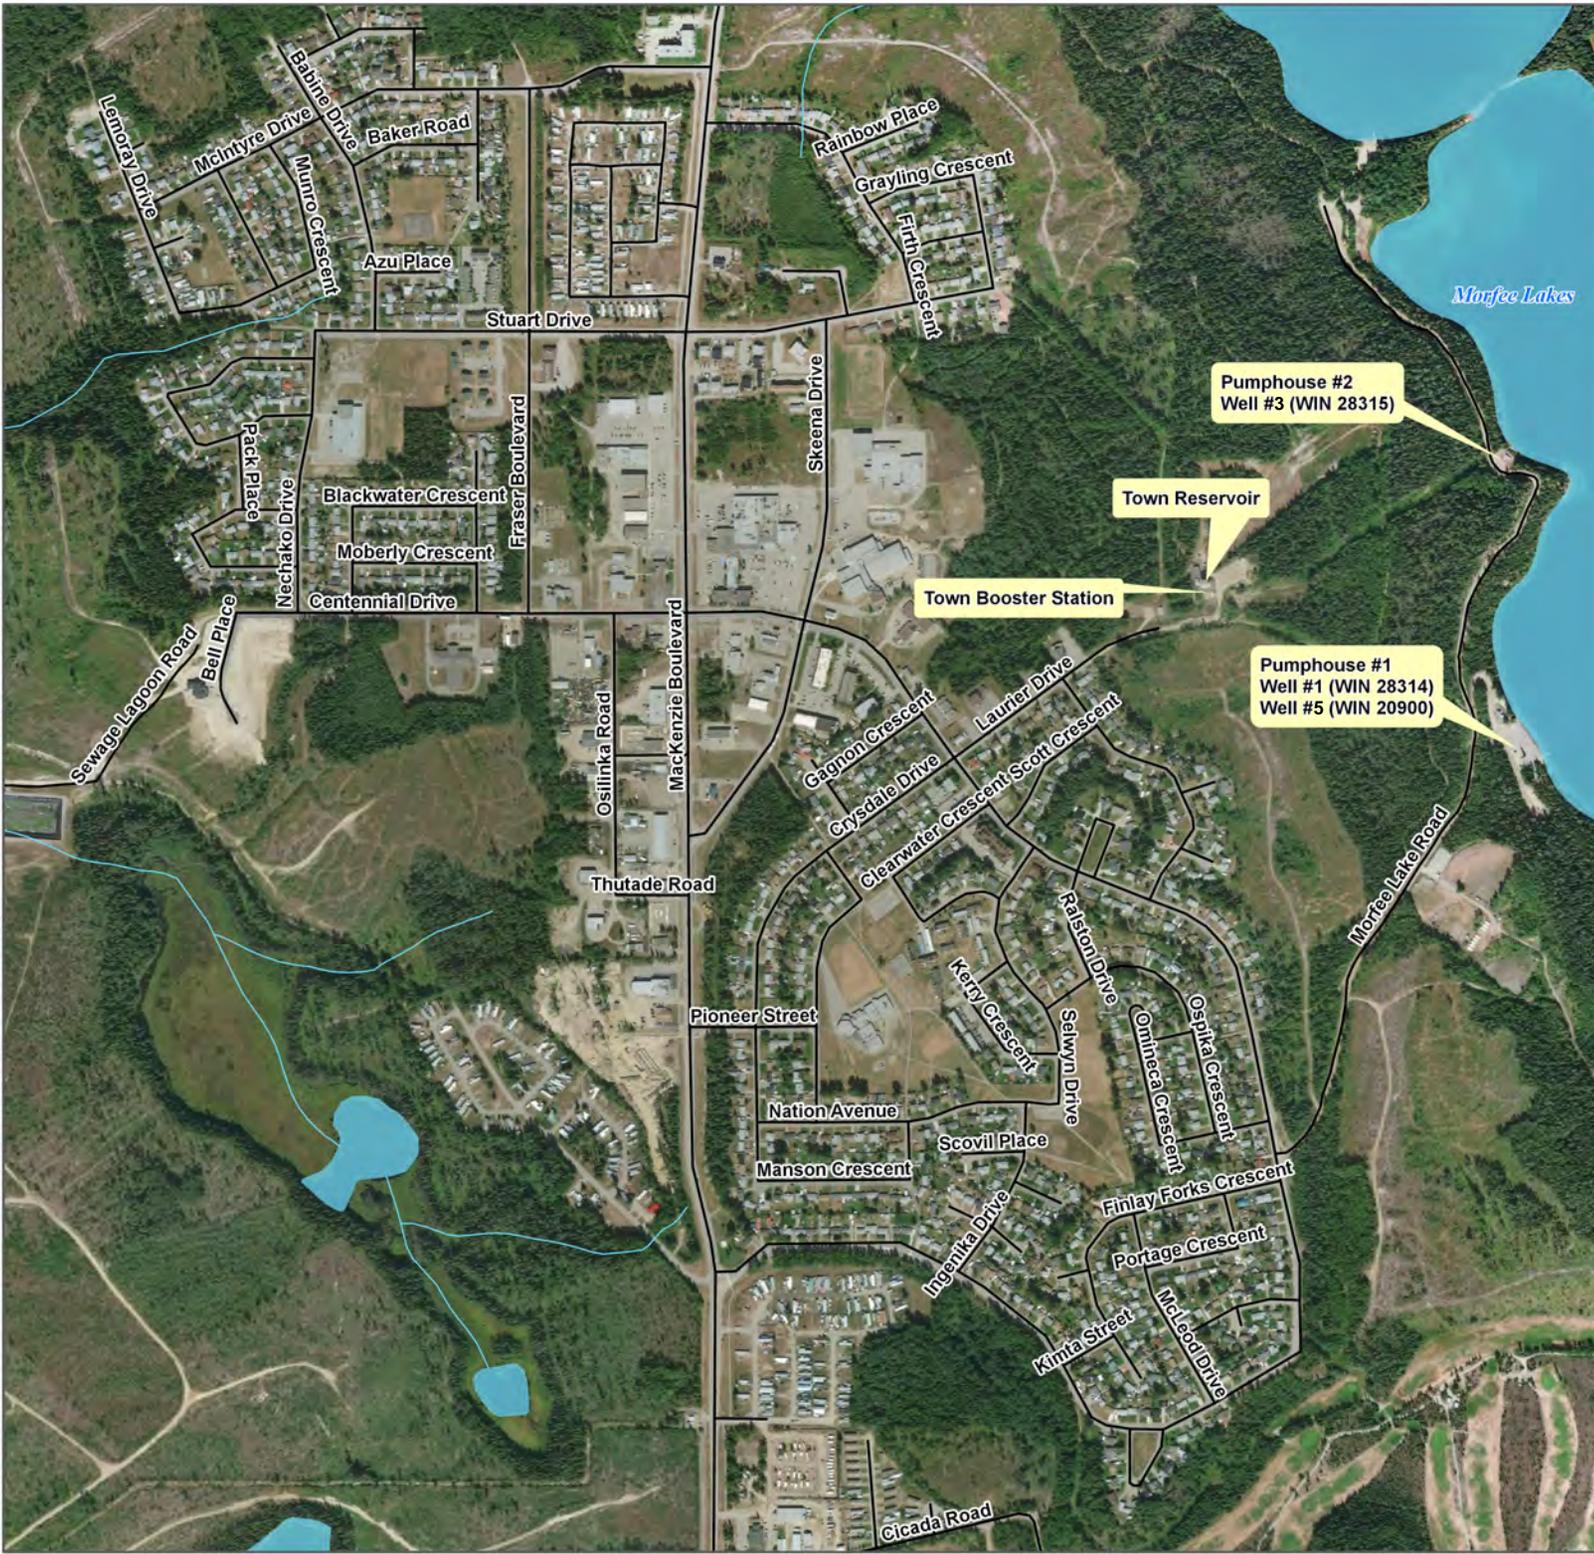
FIGURE 2.3

Figure 2.3 shows an overview of the Town System water infrastructure.

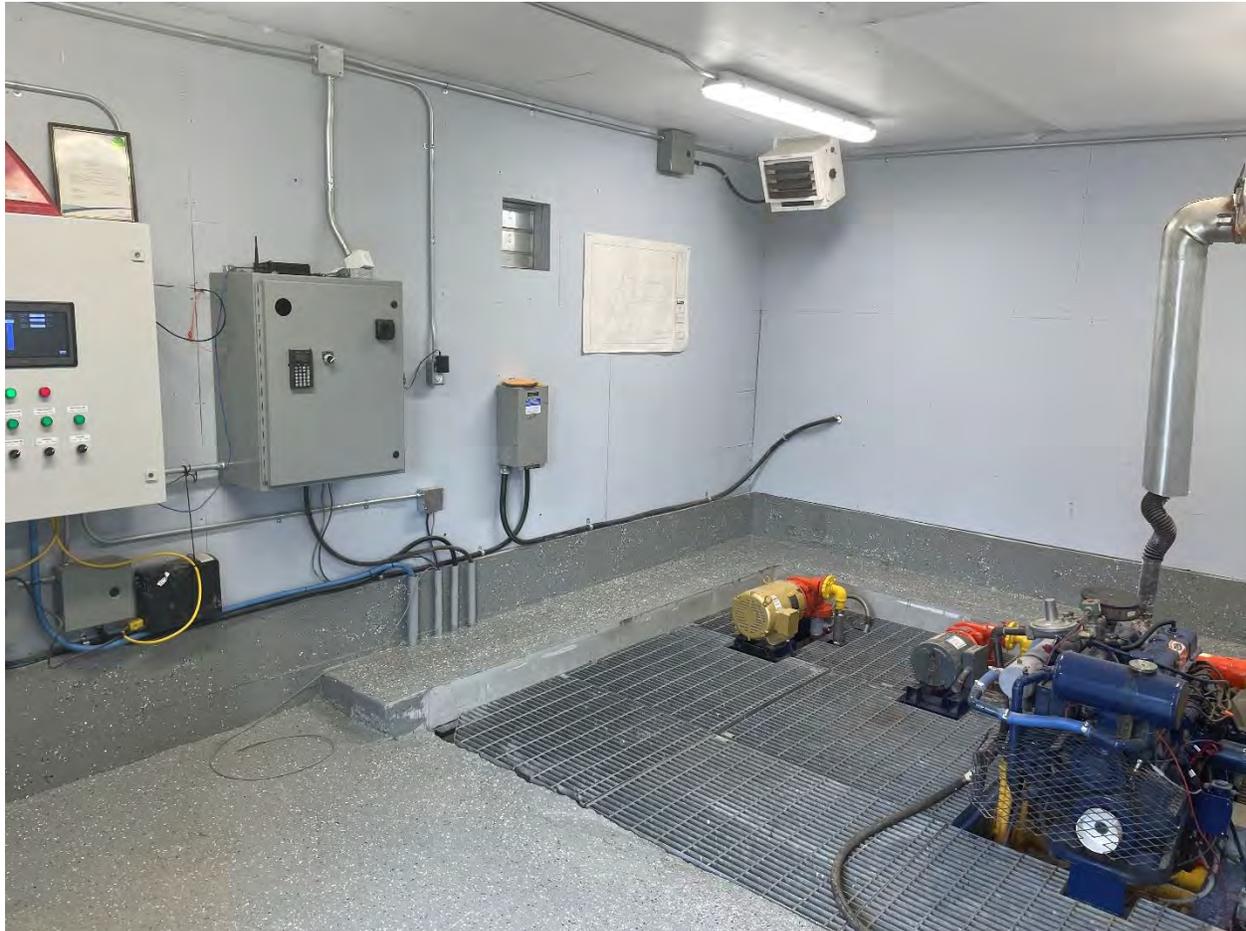
**Figure 2.4: Gantahaz Booster Station**

Similar to the Town system, the Gantahaz system is pressurized by a booster station. The Gantahaz booster station, located on Columbia Drive next to the reservoir and Well #1, supplies water from the reservoir to the subdivision. The booster station has an electric booster pump with a spare pump and motor kept in the building. An emergency natural gas fire pump is available to supplement system pressures during a fire flow event. The fire pump will start automatically based on pressures within the distribution system.

In 2019, the District completed upgrades to the Gantahaz booster station. The controls on the Gantahaz booster station were inefficient and out of date. The building was showing signs of age and had insufficient space for the proposed control equipment. Improvements included the addition of a variable frequency drive to the booster station pump for increased efficiency, building upgrades, updating the controls, improved electrical supply, and the installation of a diesel generator to power the booster pumps in the case of a power outage. This project was completed in 2019.

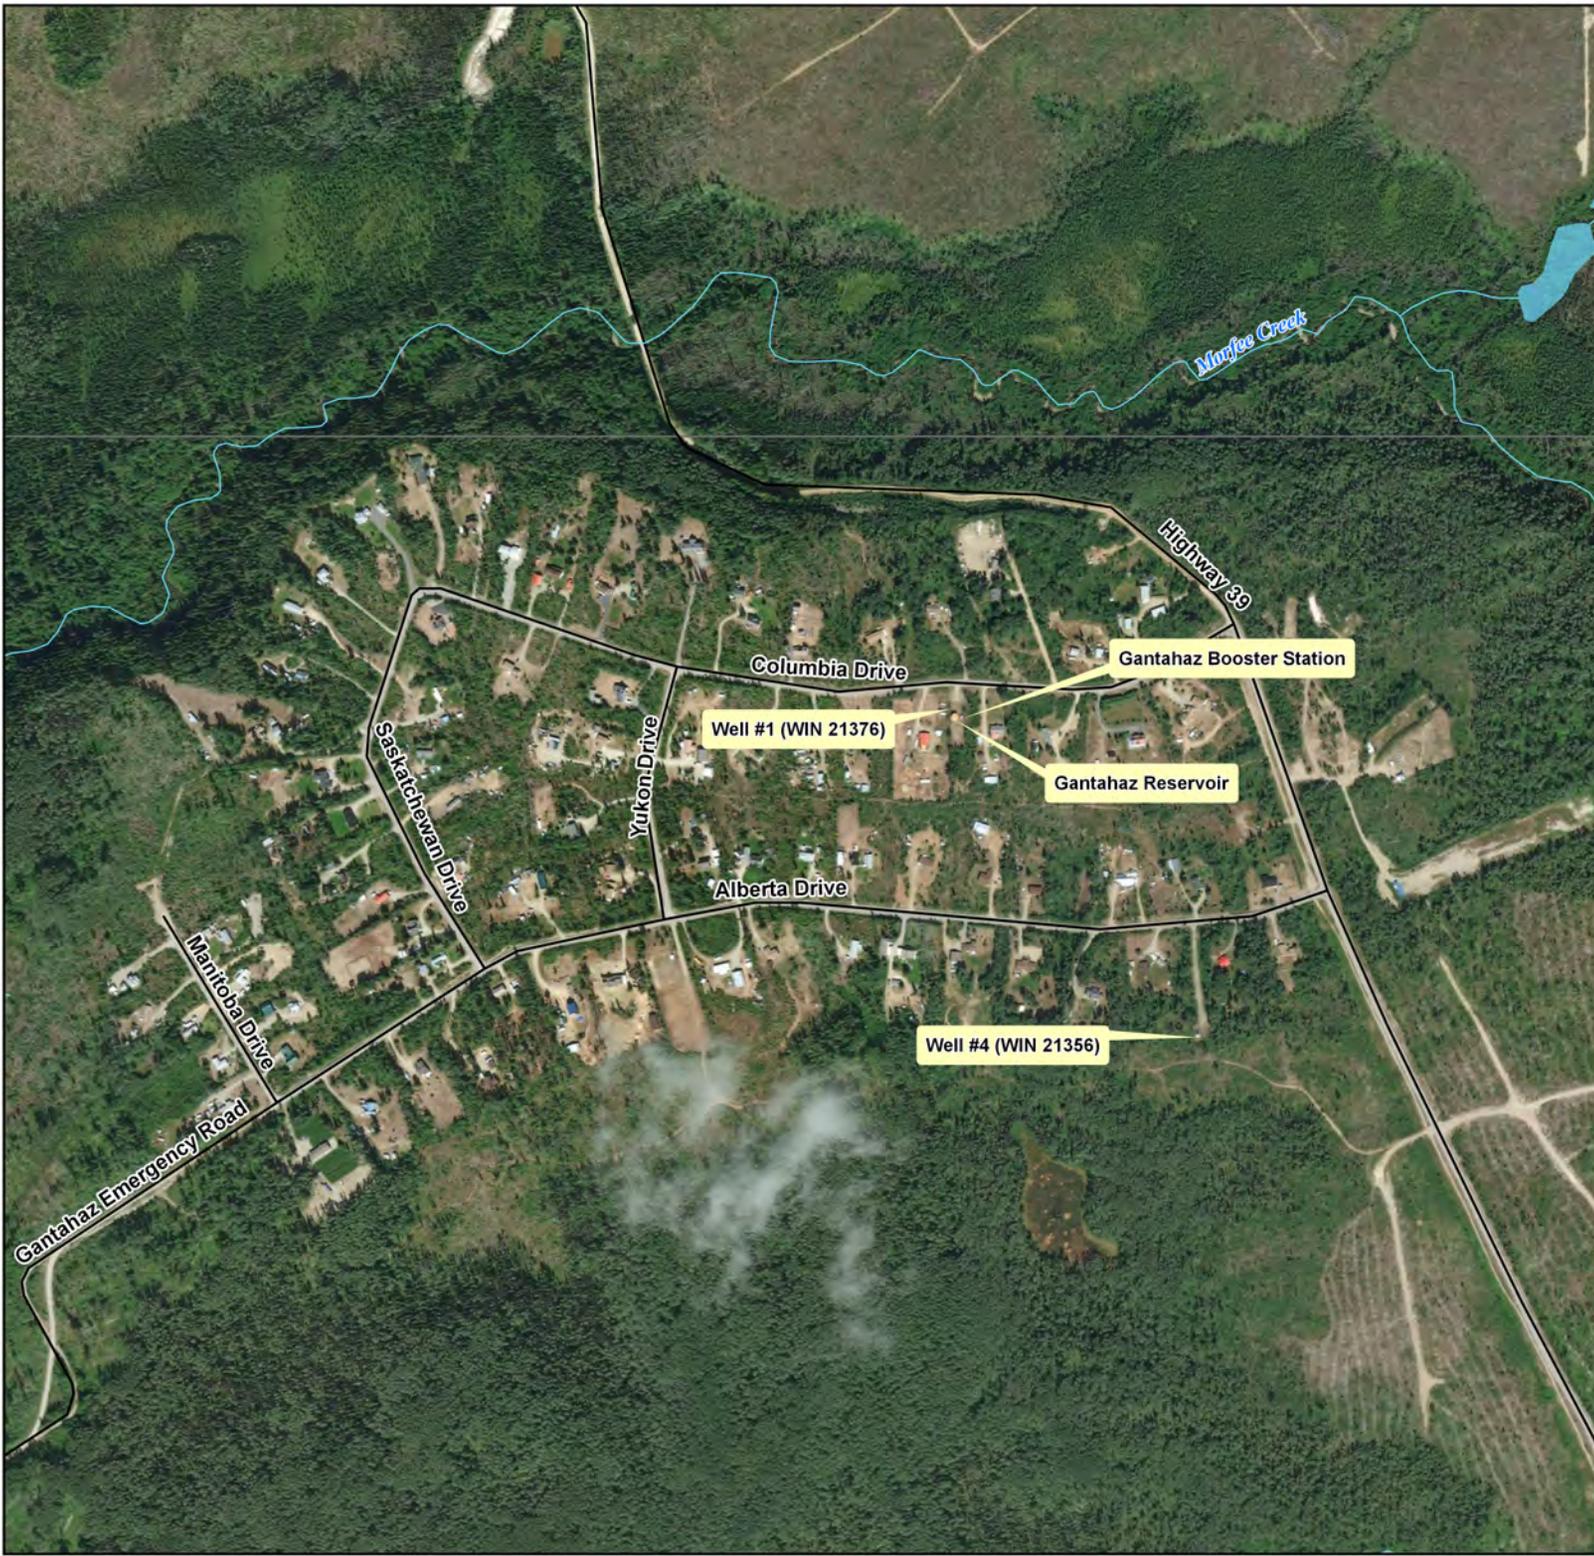
FIGURE 2.5

The Gantahaz distribution system is composed primarily of PVC pipe. The Gantahaz system has approximately 80 connections. Figure 2.5 shows an overview of the Gantahaz System water infrastructure.

District of Mackenzie  
Gantahaz Infrastructure  
Location Map

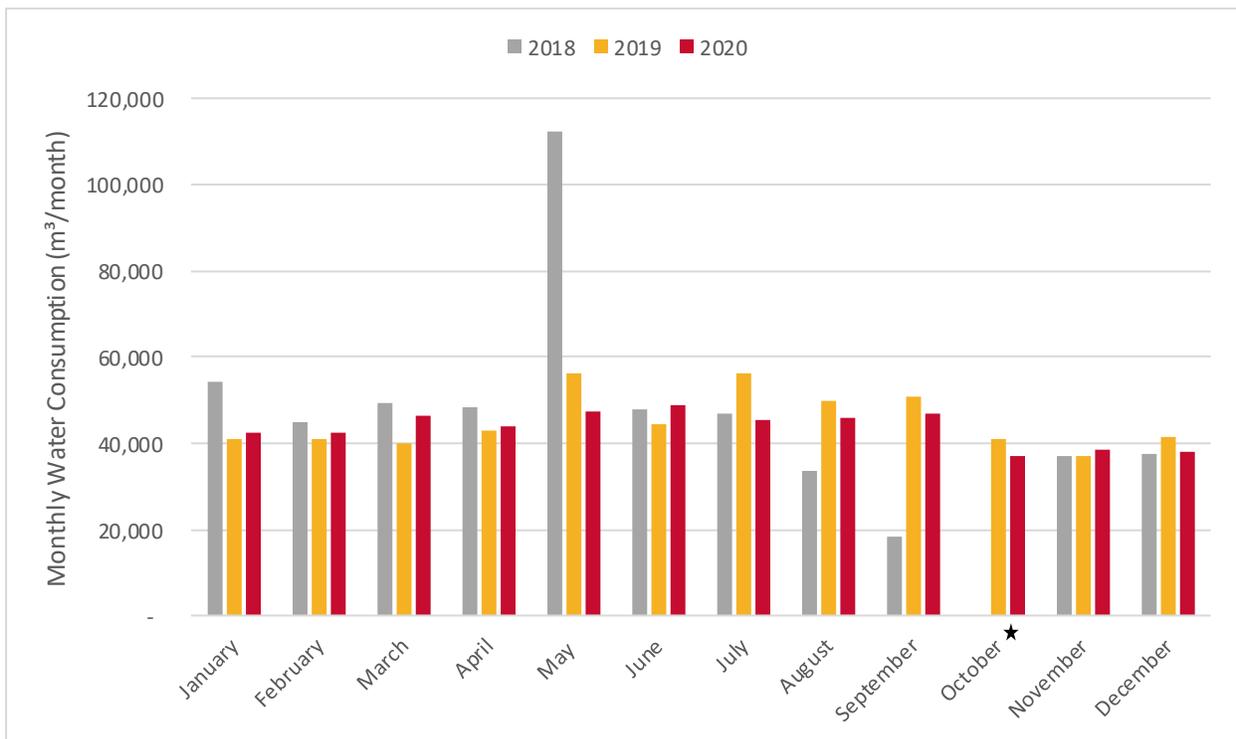
**Figure 4.1: Monthly Water Consumption for the Town Water System**

Figure 4.1 shows the monthly water consumption for the Town system in 2018, 2019 and 2020.

★ Note: Due to the upgrades to Pumphouse #1 in 2018, the monitoring equipment for the Town system was not accurate for the month of October, flow data for October 2018 has not been included as a result.

In 2020, 522,587 cubic meters of water were pumped into the Town distribution system. Water usage in 2020 was slightly lower on a per capita basis than previous years, with an average daily flow of 1432 cubic meters per day in 2020 compared to 1,483 cubic meters per day in 2019, and 1,580 cubic meters per day in 2018.

Total water consumed in 2020 was also slightly lower than previous years. In 2019, 541,253 cubic meters were pumped. In 2018, 529,979 cubic meters were pumped, excluding flows from the month of October. Due to the upgrades to Pumphouse #1, the monitoring equipment for the Town system was not accurate for the month of October, flow data for October 2018 was not available as a result.

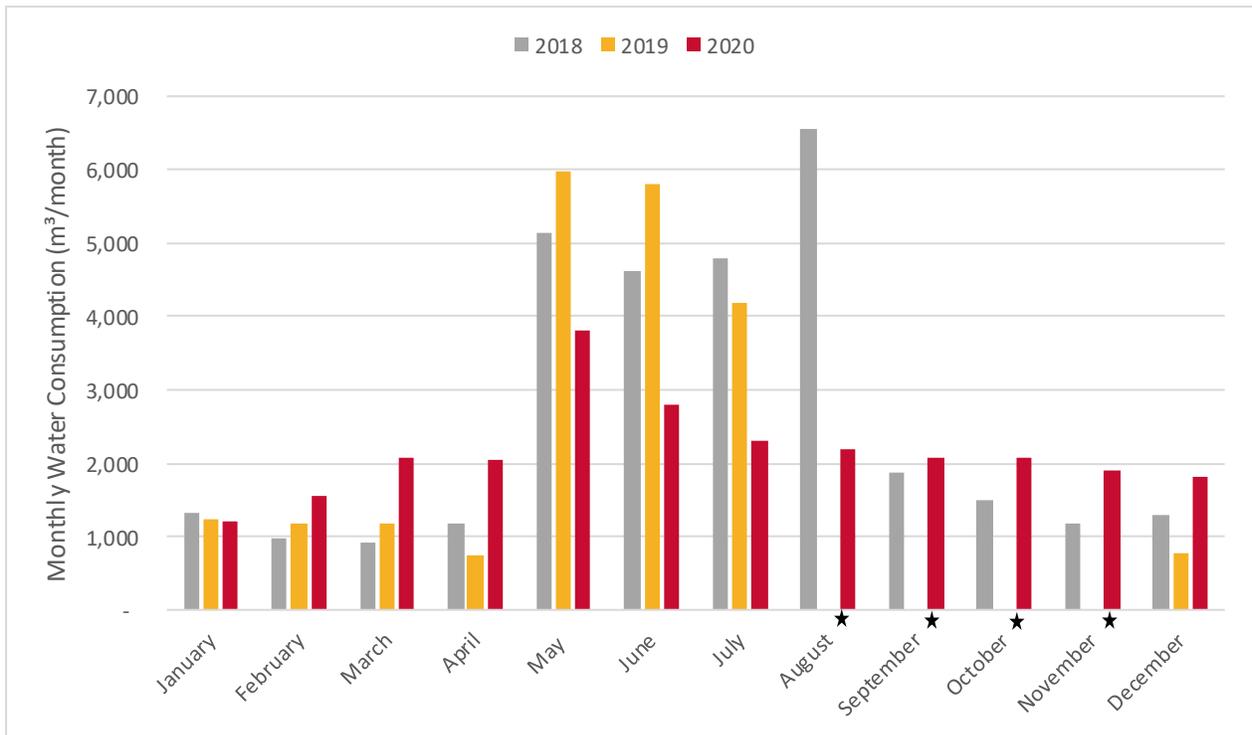
**Figure 4.2: Monthly Water Consumption for the Gantahaz Water System**

Figure 4.2 shows the monthly water consumption for the Gantahaz system.

★ Note: Due to upgrades to the control equipment in the Gantahaz booster station in Fall 2019, the monitoring equipment for the system was not accurate from August to November 2019, flow data for this period has not been included as a result.

In 2020, 25,771 cubic meters of water were pumped into the Gantahaz distribution system. This is lower than the annual Gantahaz consumption in 2018 (31,281 cubic meters of water pumped). The control equipment in the Gantahaz booster station was upgraded in Fall 2019, the flow

meter readings from August to November were not reliable as a result. Excluding August to November, the Gantahaz system pumped 21,045 cubic meters of water in 2019.

The average daily water consumption in 2020 was 71 cubic meters per day. This is lower than previous years, with an average daily flow of 87 cubic meters per day in 2019 and 90 cubic meters per day in 2018.
